## **Bulletin 2025.1** **Guidance on Recent Parker Velcon** **Product Safety Awareness Bulletins** **July 8, 2025**

## Product Safety Awareness Bulletin – First Notice

**Subject: Gaskets on Fuel Filter Elements** (Open Ended Coalescers, Separators, and various other Fuel Elements)

## Product Safety Awareness Bulletin – Second Notice

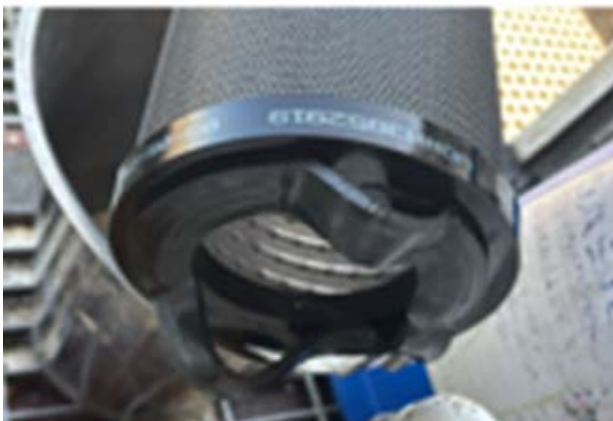
Parker Velcon has received a few notifications of the distortion of the fuel filter gasket (as identified below) upon removal of the element from the vessel. A greenish hue discoloration of the fuel has been reported after commissioning and/or flushing the filter element. This issue specifically affects the below list of filters elements manufactured between January 1, 2025, and June 20, 2025.

Parker Velcon was made aware of this on June 18, 2025. Upon further investigation with our suppliers, we have determined that the gaskets from one supplier should be recalled and that the base material is likely the cause of the distortion. The distortion has been traced back to material in the sealing gasket 05-061 used on multiple elements manufactured in our Sylacauga, AL location. Parker Velcon has two suppliers for this 05-061 gasket. There is no concern with one of our suppliers, and elements made with that gasket are 100% able to be used.

The picture below is an example of the distortion reported on June 18, 2025.

**Inspect your inventory for effected Elements:** If any elements are within the manufactured dates of January 1, 2025, and June 20, 2025, inspect them and DO NOT SHIP any elements that have the gasket considered “Remove & Return or Discard” in the below picture. If the element has the gasket considered “Keep” in the picture below, those elements can be used with no concern of distortion. The two gaskets can be visually inspected to determine which ones can be used and which ones should not be used. The “Keep” gaskets will have a smooth surface finish and sharp cut edges on the Outer and Inner Diameters. The “Remove & Return or Discard” gaskets will have a rough surface texture like leather. The edges are not as sharp but appear to be slightly jagged. Please contact Parker Velcon as soon as possible for assistance. Replacement elements filters will be provided for all elements with the effected gaskets. We are still gathering information and will continue to investigate to provide a more detailed notice and instructions as soon as we can.

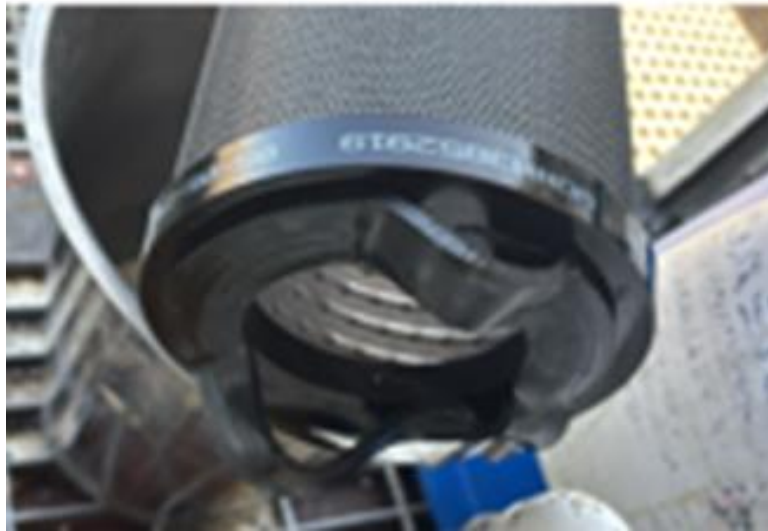
Parker Velcon has received a number of notifications of the distortion of the fuel filter gasket (as identified below) upon removal of the element from the vessel. A greenish hue discoloration of the fuel was reported after commissioning and/or flushing the filter element. This issue specifically affects shipments of the below list of filter elements manufactured between January 1, 2025, and June 20, 2025. This attached list of affected elements has been reduced from the prior list based on part numbers built and shipped during this time from our manufacturing facility.

Parker Velcon was made aware of this issue on June 18, 2025. Upon further investigation with our suppliers, we have determined that the gaskets from one supplier are in question and that the base material is likely the cause of the distortion. The distortion has been traced back to material in the sealing gasket 05-061 used on multiple elements manufactured in our Sylacauga, AL location. Parker Velcon has two suppliers for this 05-061 gasket. There is no concern with one of our suppliers, and elements made with that gasket have no known issues and may be used.

The picture below is an example of the distortion that was reported on June 18, 2025.

2. **Inspect your inventory for effected Elements:** If any elements are within the manufactured dates of January 1, 2025, and June 20, 2025, inspect them and DO NOT SHIP any elements that have the gasket similar to the gasket labeled “Not Acceptable” in the below picture. If instead the element has the gasket similar to “Acceptable” in the picture below, it may be used with no concern of distortion. The two gaskets can be visually inspected to determine which can be used and which should be quarantined. The “Acceptable” gaskets will have a smooth surface finish and sharp cut edges on the Outer and Inner Diameters. The “Not Acceptable” gaskets will have a rough surface texture, similar to leather. The edges are not as sharp but appear to be slightly jagged. Please contact Parker Velcon as soon as possible for assistance. Replacement filter elements or rework will be provided for all elements with the affected gaskets.

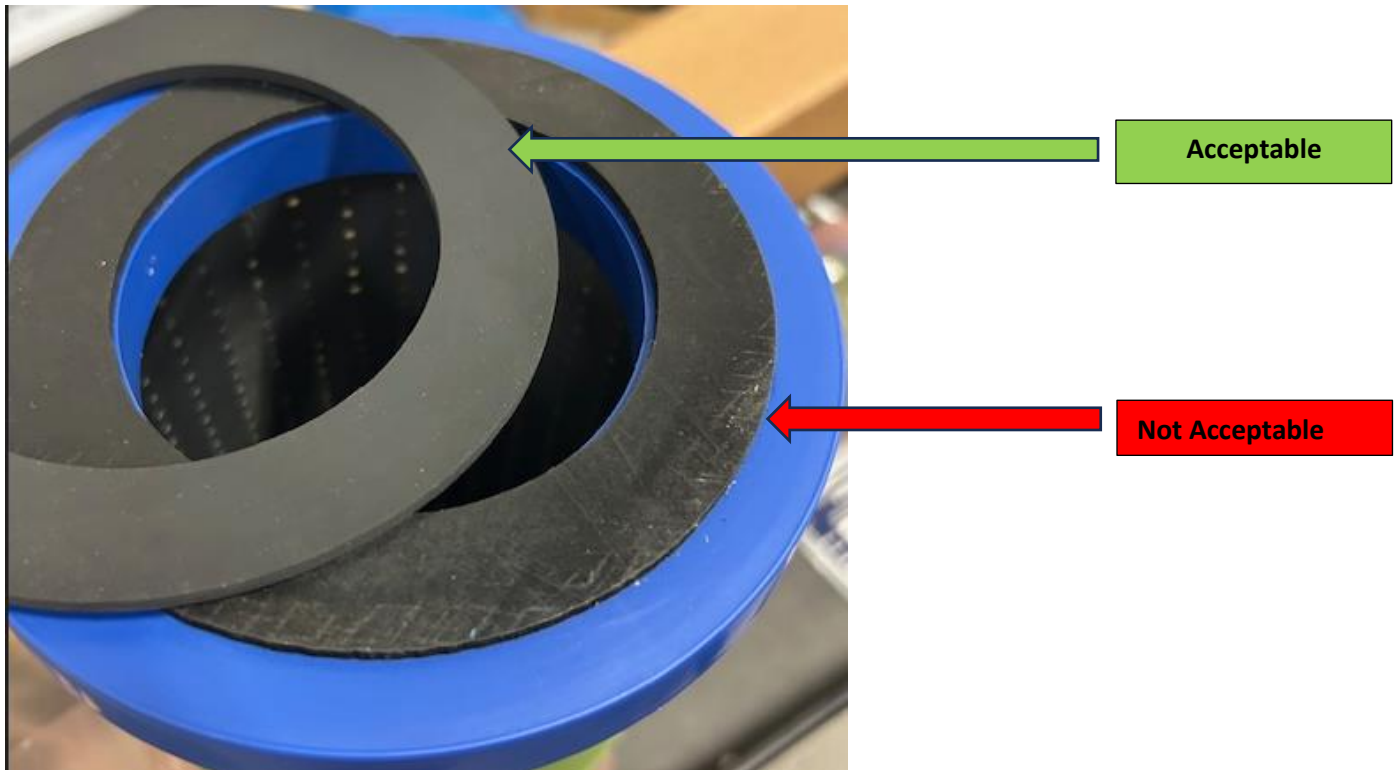
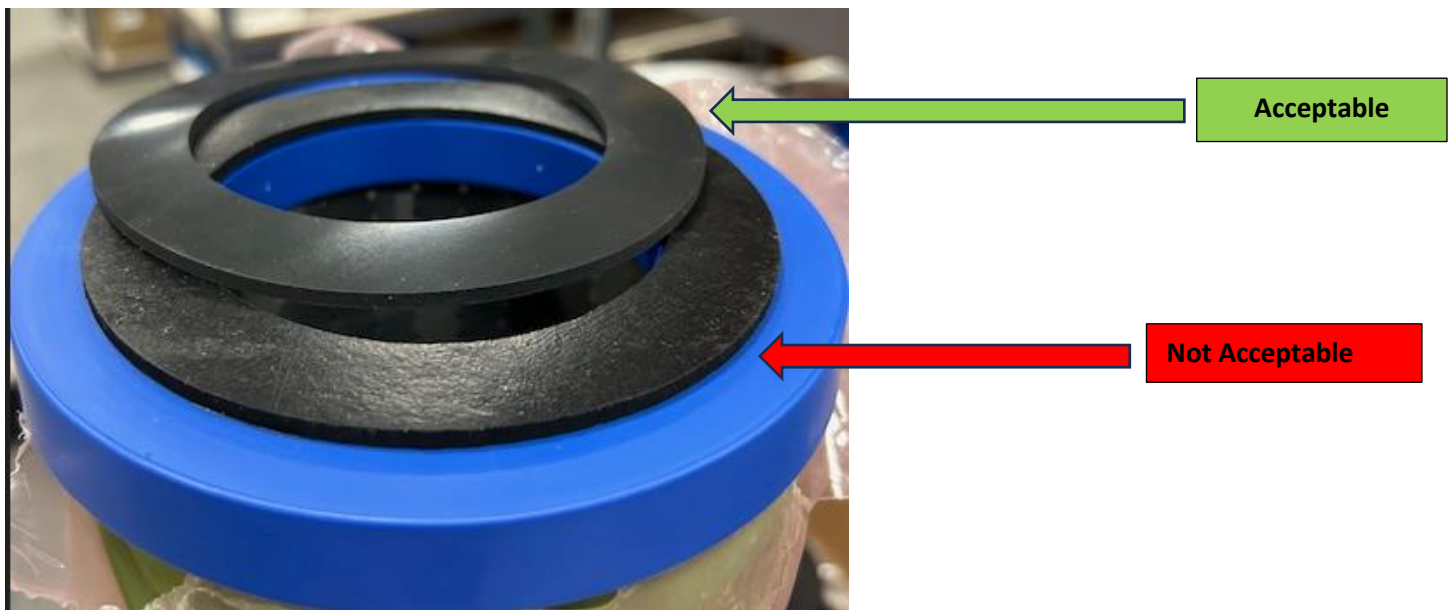
**Additional Pictures of gaskets showing visual differences:**

- c) Dry the gasket with a clean cloth to allow for a better visual of the gasket.
      - d) Determine if the gasket is acceptable or if non-acceptable as illustrated in the pictures above.

- e) Elements with non-acceptable gaskets are required to be replaced.
      - f) Elements with gaskets that cannot be confirmed as acceptable should also be replaced.

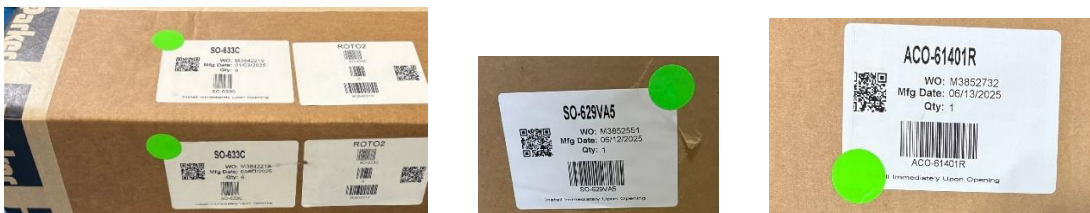
1. **Inventory Inspection:** All gaskets in inventory at our factory have been quarantined. All work in process and finished elements using this gasket have also been quarantined. All inventory of gaskets and finished elements were inspected to ensure that no other products leave our facility.
2. **Inventory Correction:** All inventory of “**Not Acceptable**” gaskets have been removed from our manufacturing facility and all finished goods have been repaired to ensure that the “**Acceptable**” gaskets are on all product in our facility.
  - Elements built within this date range at our facility will have a verified sticker located on the box label and/or on the bag holding the element based on the individual part number. See picture below showing sticker and placement on packaging.
